**DEPARTMENT OF TRANSPORTATION****DIVISION OF ENGINEERING SERVICES**

Contract #: 04-0120F4Cty: SF/ALA Rte: 80 PM: 13.2/13.9File #: 69.28**WELDING INSPECTION REPORT****Resident Engineer:** Pursell, Gary**Address:** 333 Burma Road**City:** Oakland, CA 94607**Report No:** WIR-007911**Date Inspected:** 17-Jul-2009**Project Name:** SAS Superstructure**OSM Arrival Time:** 1900**Prime Contractor:** American Bridge/Fluor Enterprises, a JV**OSM Departure Time:** 700**Contractor:** Zhenhua Port Machinery Company, Ltd (ZPMC), Changxing Island **Location:** Shanghai, China**CWI Name:** Zou Liu Hai**CWI Present:** Yes No**Inspected CWI report:** Yes No N/A**Rod Oven in Use:** Yes No N/A**Electrode to specification:** Yes No N/A**Weld Procedures Followed:** Yes No N/A**Qualified Welders:** Yes No N/A**Verified Joint Fit-up:** Yes No N/A**Approved Drawings:** Yes No N/A**Approved WPS:** Yes No N/A**Delayed / Cancelled:** Yes No N/A**Bridge No:** 34-0006**Component:** Tower struts and OBG floorbeam**Summary of Items Observed:**

**OBG sub assembly bay 2**

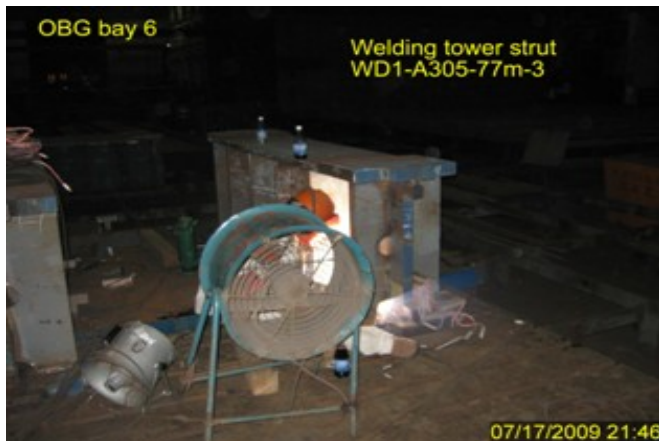
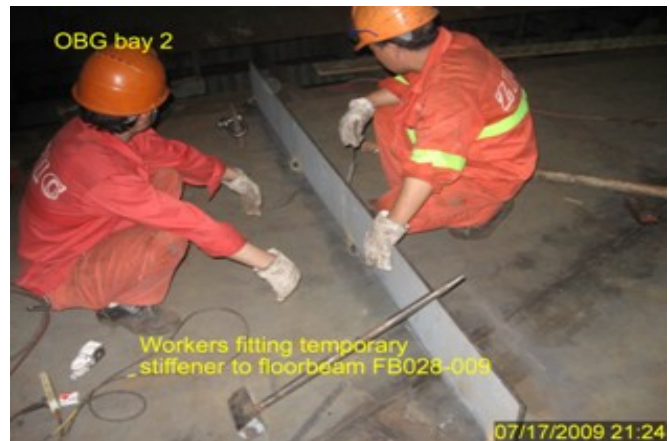
This QA observed ZPMC personnel fitting a temporary stiffener to OBG floorbeam identified as FB028-009. This QA noted that this floorbeam is an FL3 and the stiffener was being tacked welded to the SPCM portion of this floorbeam. This QA reviewed the approved OBG assembly procedure and it appeared as though this temporary stiffener was indicated on the procedure drawing. No further action was taken by this QA concerning this issue.

This QA observed ZPMC qualified welding personnel identified as 068091 perform SMAW welding on weld joint identified as WD1-305-65M-3-2B. ZPMC QC CWI identified as Mr. Zou Liu Hai was present to monitor the welding process. The welding parameters as measured using QC's calibrated instruments appeared to be in general compliance with WPS-B-T-3212-Tc-U5b-1.

This QA observed ZPMC qualified welding personnel identified as 037932 perform SMAW welding on weld joint identified as WD1-305-65M-3-8A. ZPMC QC CWI identified as Mr. Zou Liu Hai was present to monitor the welding process. The welding parameters as measured using QC's calibrated instruments appeared to be in general

compliance with WPS-B-T-3212-Tc-U5b-1.

This QA observed ZPMC qualified welding personnel identified as 066456 perform SMAW welding on weld joint identified as WD1-A305-77M-3-8A. ZPMC QC CWI identified as Mr. Zou Liu Hai was present to monitor the welding process. The welding parameters as measured using QC's calibrated instruments appeared to be in general compliance with WPS-B-T-3212-Tc-U5b-1.

This QA observed ZPMC qualified welding personnel identified as 037780 perform SMAW welding on weld joint identified as WD1-A305-77M-3-2B. ZPMC QC CWI identified as Mr. Zou Liu Hai was present to monitor the welding process. The welding parameters as measured using QC's calibrated instruments appeared to be in general compliance with WPS-B-T-3212-Tc-U5b-1.

This QA observed ZPMC personnel drilling holes in the flanges of several of the tower struts in this bay. No other work was observed in this bay during the time QA was present.
